Manhole Inspection Summary

Manhole # S67G__020MH

Insp Date: **5/27/08 8:13 AM**

Location Address: **Gusryan**

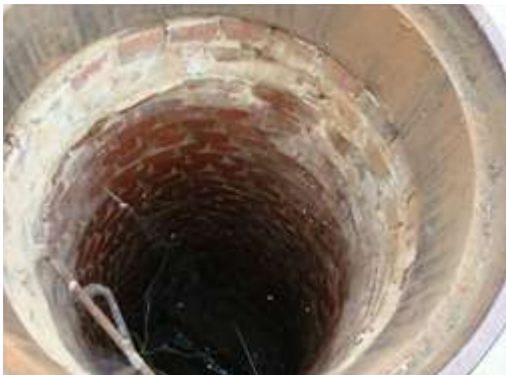
Defect 1

Condition: ☐ Sound ☐ Cracked ☐ Root Intrusion ☒ **Loose Brick** ☐ Deteriorated

Infiltration: ☐ None ☒ **Joint** ☐ Cracks ☒ **Mortar** ☐ Roots ☐ Wall

infiltration

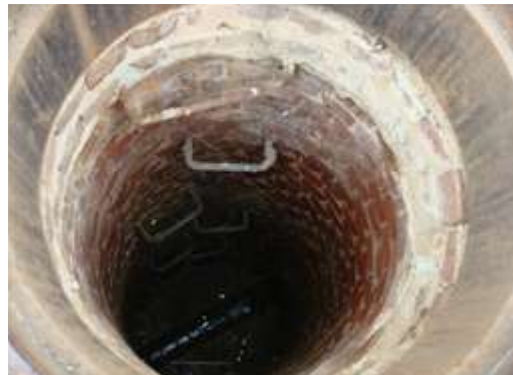
Defect 2

frame leaks

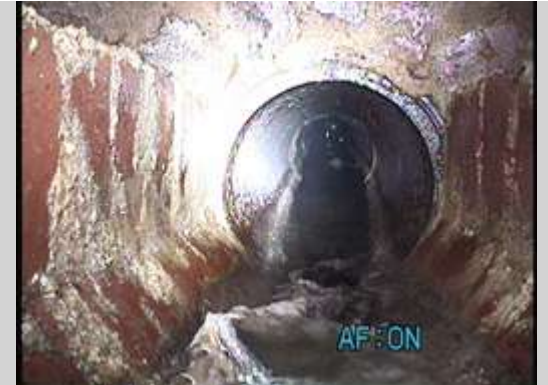
12 O'Clock Outflow

Pipe Height: **8.4** (in.) Rod and Bar (Angled)
Pipe Material: **Clay** ☐ Pipe Lined
Invert Depth: **14.15** (ft.) Flow Characteristics: **Fast**
Deposits: ☒ None ☐ Mud ☐ Sludge ☐ Debris ☐ Grease
Silt Depth: (in.) Deposits Extent:
Infiltration: **None** Pipe Seal Cond: **Sound**

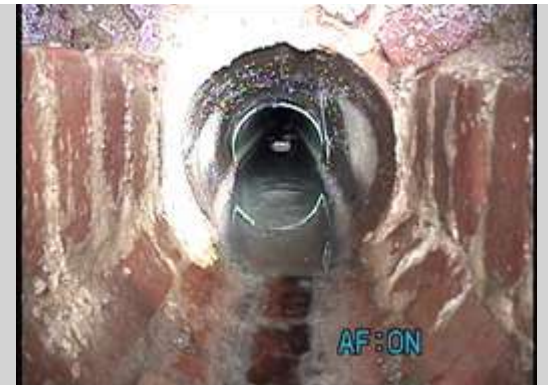
6 O'Clock Inflow

Pipe Height: **8.4** (in.) Rod and Bar (Angled)
Pipe Material: **Clay** ☐ Pipe Lined
Invert Depth: **13.90** (ft.) Flow Characteristics: **Fast**
Deposits: ☒ None ☐ Mud ☐ Sludge ☐ Debris ☐ Grease
Silt Depth: (in.) Deposits Extent:
Infiltration: **None** Pipe Seal Cond: **Sound**
